Title: **Measurement of Ground Deformation Induced by Liquefaction and Faulting
in the Earthquake Area of the 1999 Kocaeli Earthquake**

ABSTRACT

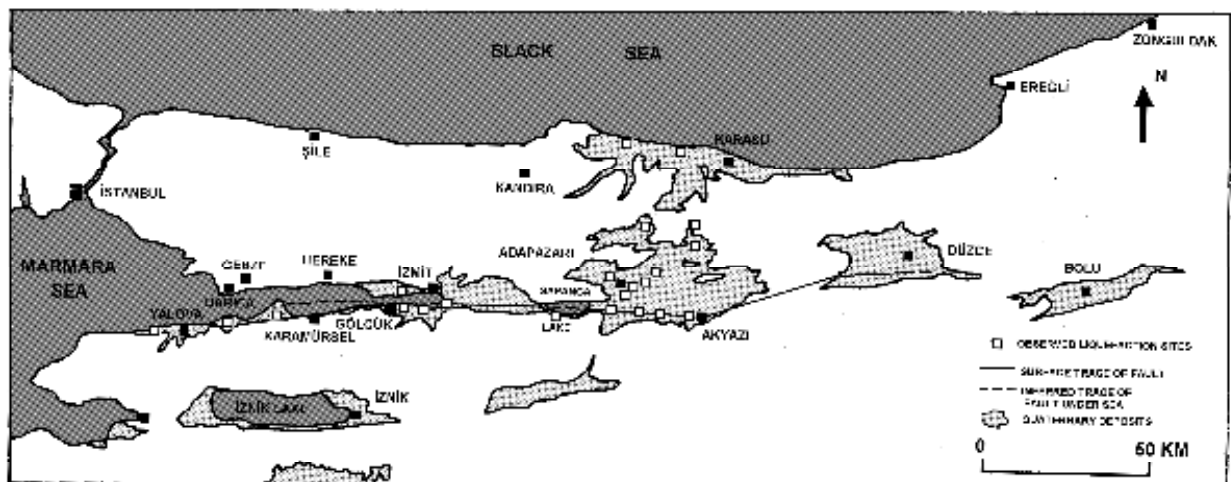
Figure 1. Liquefaction locations observed during Kocaeli earthquake of Aug. 17,1999

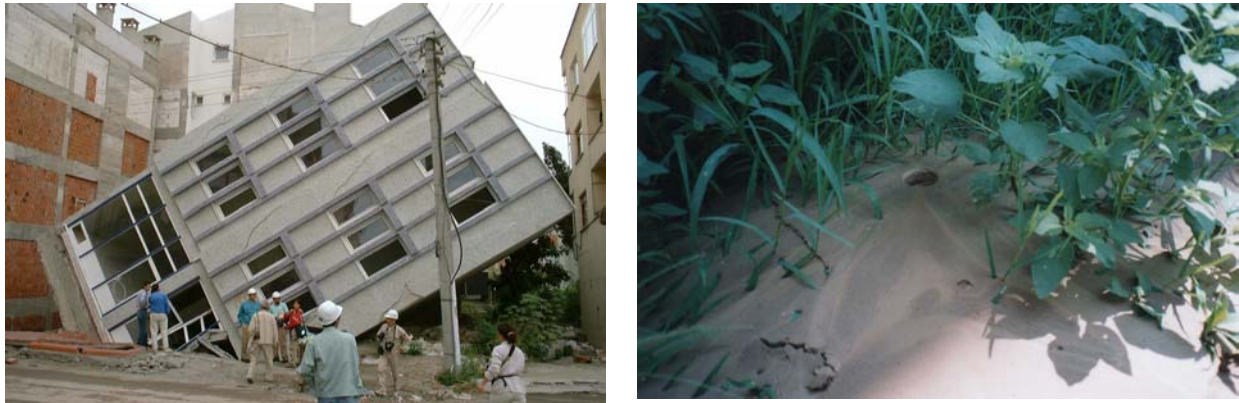
Figure 2: Examples of liquefaction in Adapazari

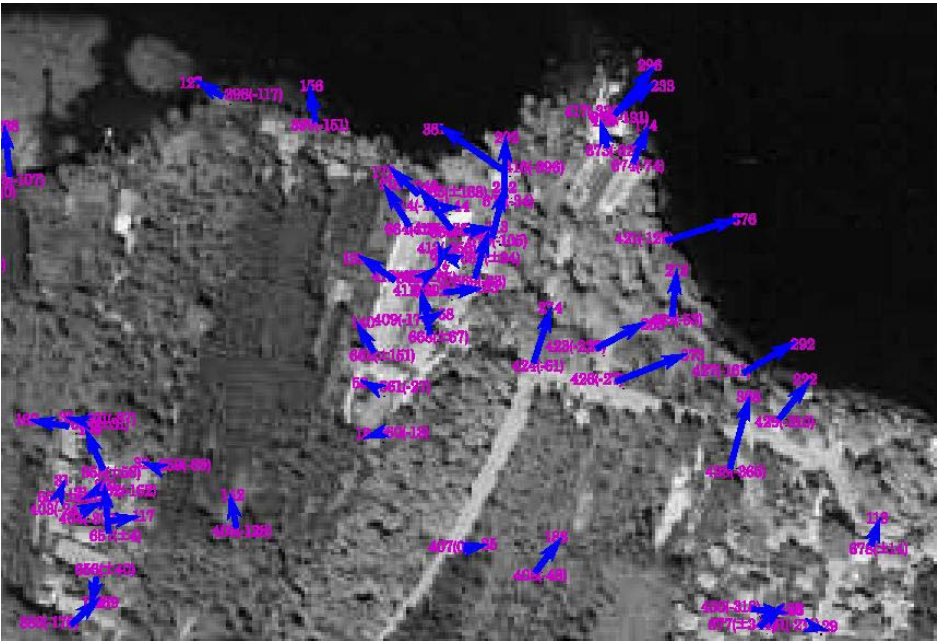
418 points have been measured in the area of Sapanca Otel. Displacement vectors have direction mainly to north, upward the Lake because of the liquefaction (Figure 3).

Figure 3. Displacement vectors around the Sapanca Hotel

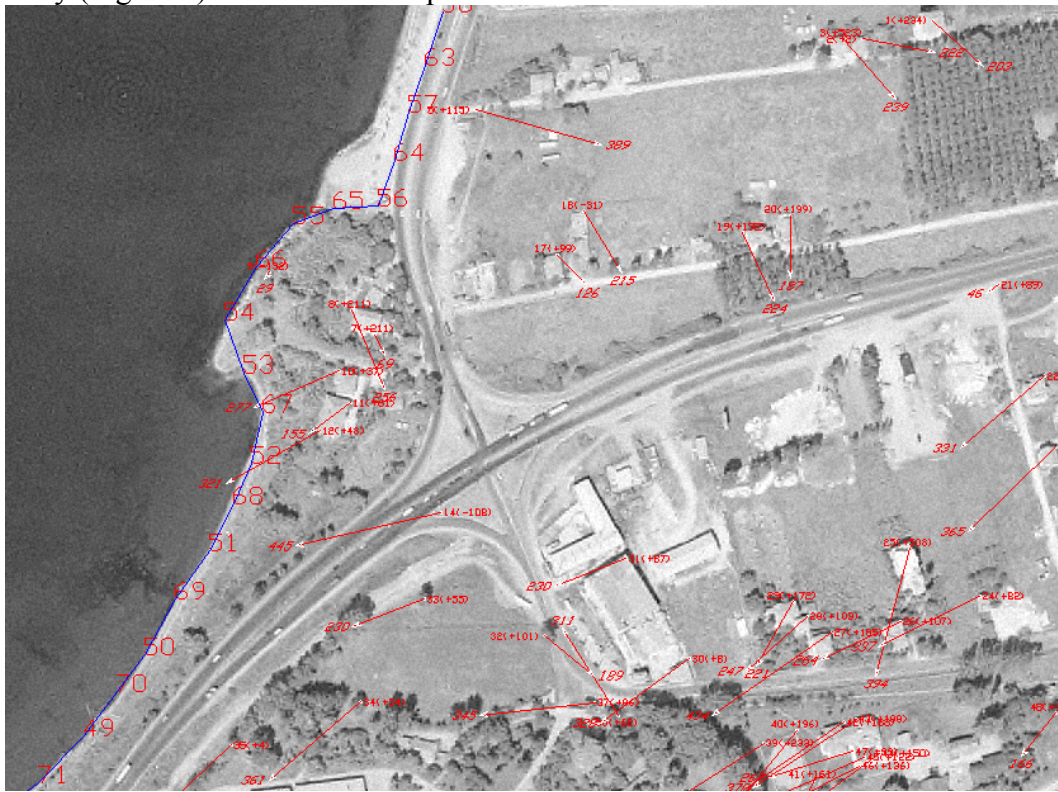
Some other measurements were also implemented in eight different areas on the coastline of Izmit Bay (Figure 4) in addition to Sapanca Lake. Obtained results can be seen in Table II.

Figure 4. Displacement vectors at Basiskele
