Title: Measurement of Ground Deformation Induced by Liquefaction and Faulting in the Earthquake Area of the 1999 Kocaeli Earthquake

O. Aksu, J. P. Bardet, V. O. Atak, M. Onder, O. Aydan

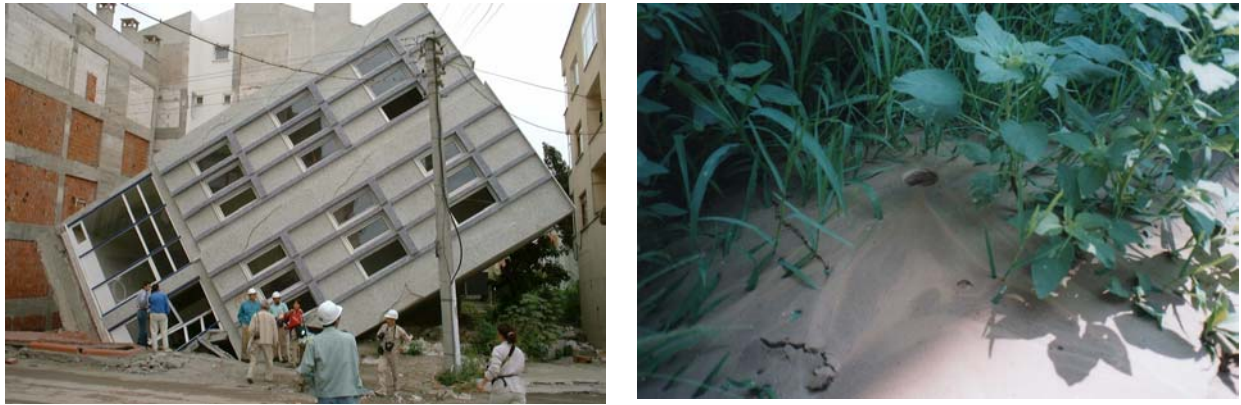
Figure 2: Examples of liquefaction in Adapazari

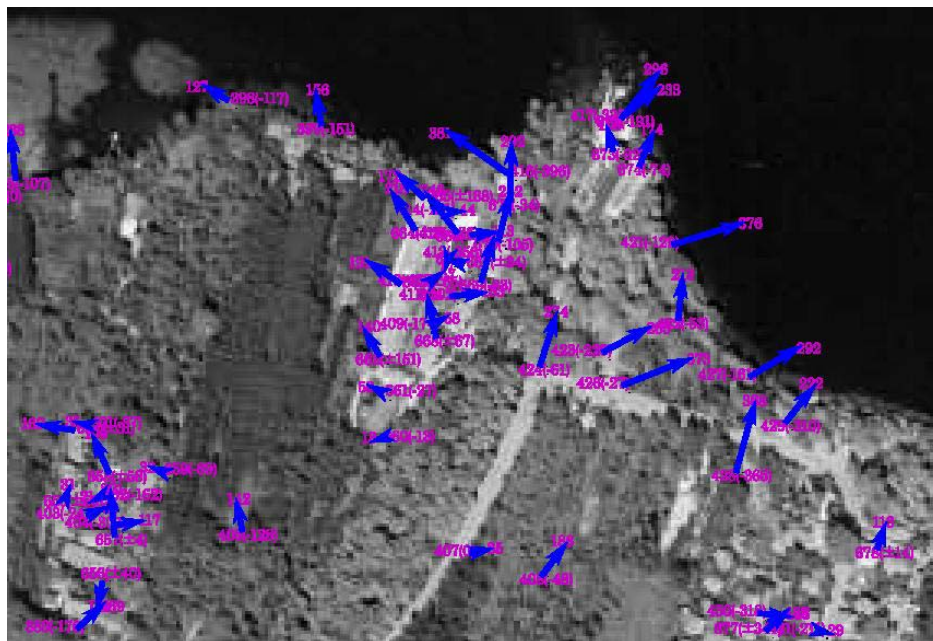
418 points have been measured in the area of Sapanca Otel. Displacement vectors have direction mainly to north, upward the Lake because of the liquefaction (Figure 3).

Figure 3. Displacement vectors around the Sapanca Hotel
